Candover habitat improvement monitoring results

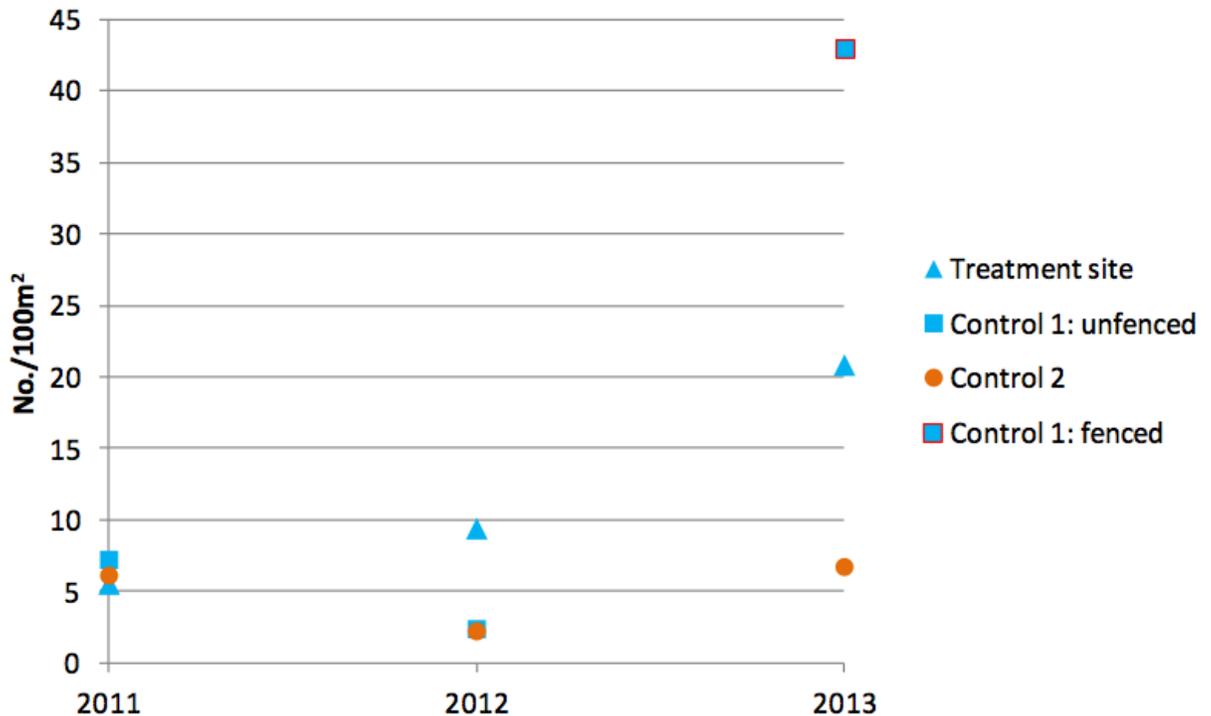
Chart Itchen 13: Candover habitat enhancement project trout densities

Chart Itchen 13 shows wild brown trout density at each site in 2011, 2012 and 2013, based on single run electric fishing over 100m of channel.

Chart Itchen 13 demonstrates that in 2011, before any trout habitat enhancement had commenced trout abundance at both control sites and at the proposed treatment site was similar at between 5 and 7 individuals per 100m². In 2012, the effects of the enhancement works at the treatment site were apparent in that year's survey data, with approximately a halving of trout abundance at both control sites and close to a doubling at the treatment site.

The 2013 survey data indicates a more than doubling of trout abundance at the remaining control site (Control 2), between 2012 and 2013 to a value similar to that recorded in 2011. However, abundance at this site remains low compared to less impacted sites on the same stream.

Following the enhancement of Control 1 in late 2012, trout abundance increased more than 17- fold: showing a far greater response to the improvement works than to natural variation. Similarly at the original treatment site, trout abundance more than doubled between 2012 and 2013, probably reflecting further maturation and colonisation of the enhancement measures.

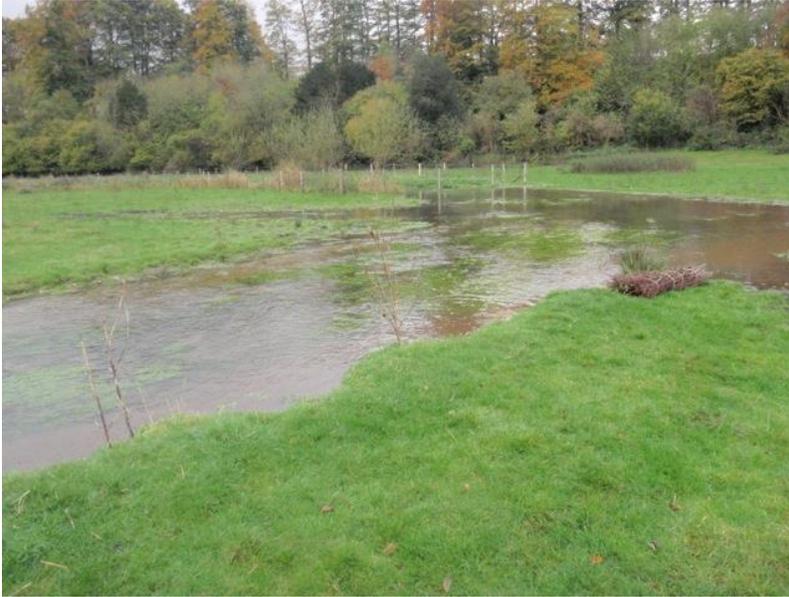
Image showing downstream from an unfenced area towards a fenced area.

The remarkable increase in trout abundance at Control 1 is a typical response to the fencing of chalkstream headwaters chronically impacted by livestock poaching. The initial major change in the habitat is prolific growth of marginal watercress, producing a fast, sinuous open channel, relatively deep compared to the unfenced one. As a result, there is a rapid increase in cover available for trout, boosting the reach carrying capacity significantly. It's worth noting that even though the total number of trout caught in this newly fenced reach increased from fourteen in 2012 to forty in 2013, in the same period the encroaching watercress reduced the total area available as fish habitat from 596m² to 93m². This is a clear demonstration of the general principal that a narrow channel with excellent habitat quality will tend to support a greater abundance of fish than the same length of wide channel with poor habitat.

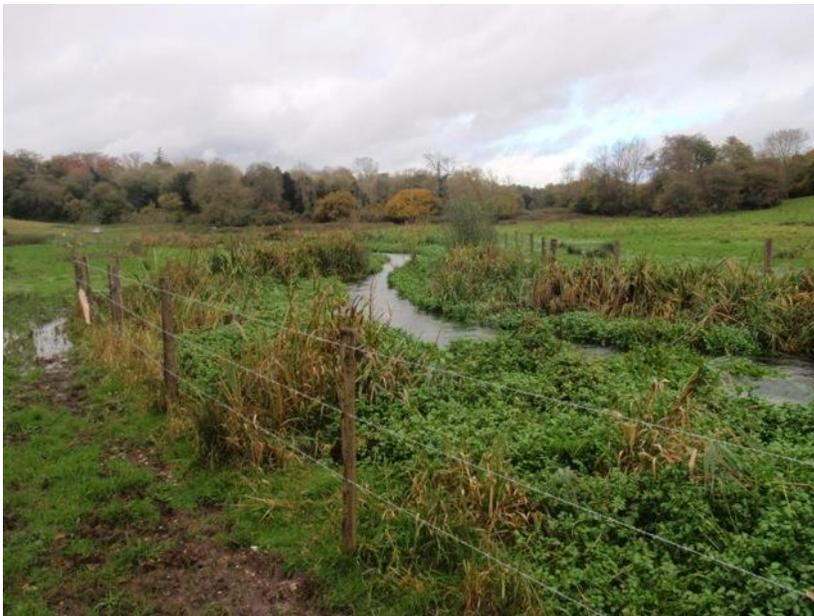
Image showing upstream into a fenced area
